# OHIO HISTORIC INVENTORY CODED

Butler-301-4  
Butler  
Peter Schrock, Jr., Farm

4. Present Name(s) Peter Schrock, Jr., Farm  
5. Other Name(s) N/A

CHRISTIAN AUGSPURGER AMISH/MENNONITE SETTLEMENT OF BUTLER COUNTY, OHIO

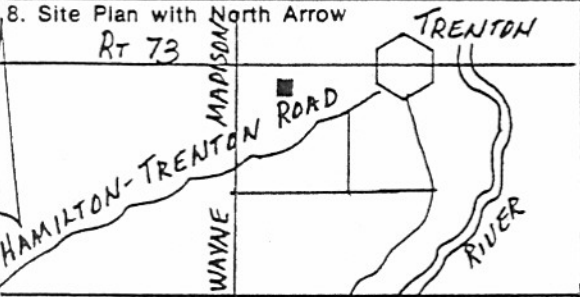
42. Further Description of Important Features This attractive house has two front doors with a two bay porch of cut-out wood. The 6/6 DHS have flat lintels and sills with shutters. The frieze is dentillated with paired brackets. There are quarter fan windows in the attic gables. The wing to the rear once had a porch to the east. The inside once had three closed stairways. One went to the hired hand's room. The plain wide woodwork and the plain mantels in each of the downstairs rooms are impressive. The fireplaces have flanking cupboards in both down parlors.
