OHIO HISTORIC INVENTORY

1. No. But-300-4	4. Present Name(s) Christian Ehresman Farm
2. County Butler	5. Other Name(s) N/A
3. Location of Negatives Trenton Historical Society

Butler Christian Ehresman Farm

CHRISTIAN AUGSPURGER AMISH MENNONITE SETTLEMENT IN BUTLER COUNTY, OHIO

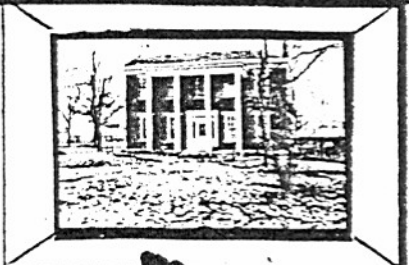
42. Further Description of Important Features This house has flat lintels and sills on 6/6 DHS. A central doorway has transom and sidelights. There is a two story front portico added to the facade. The house has two internal end chimneys and a cut stone water table. The interior features a center hallway with open stairway. The porch and door alterations do not obscure the basic house type represented and are of a reversible nature.

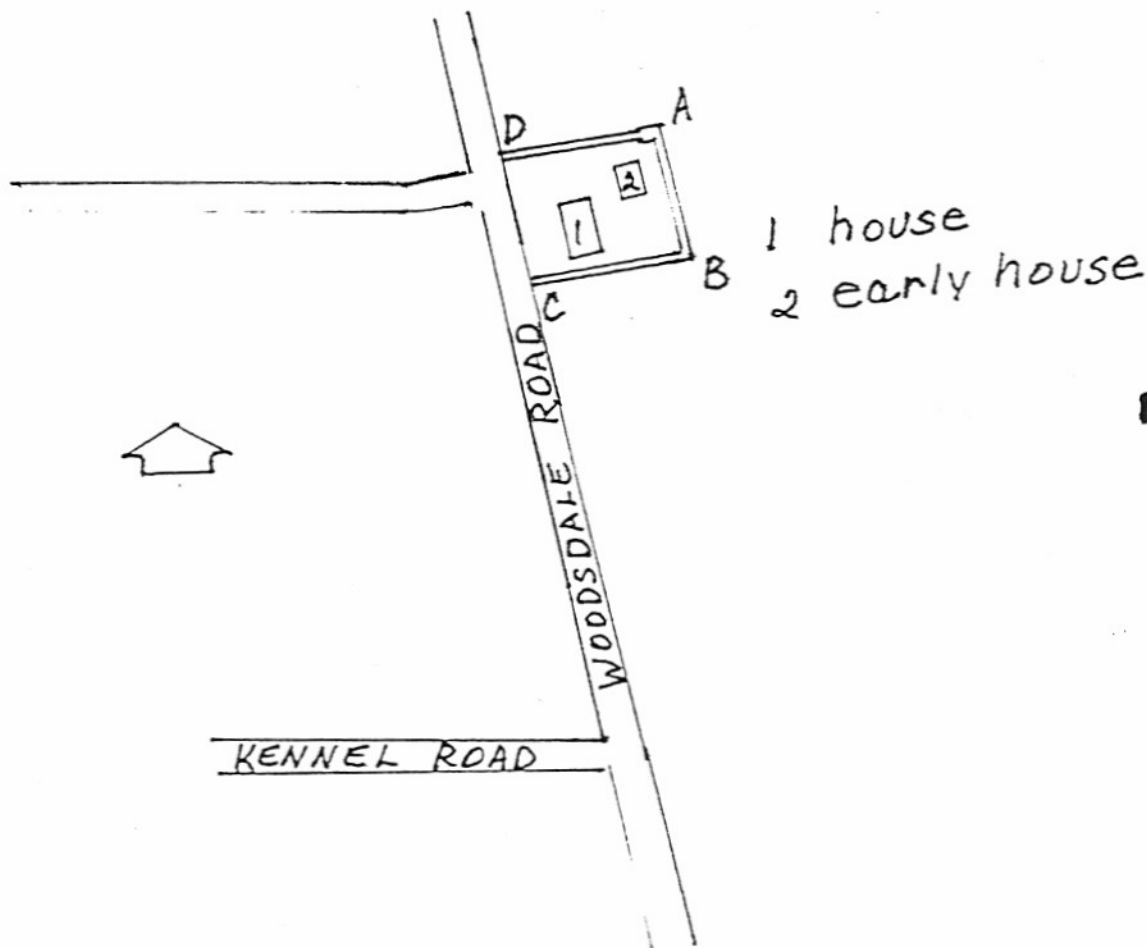
Beginning at the northeast corner of the yard marked by a corner fence post and denoted as Point A, go south 150 feet along the yard line to the southwest corner of the yard, denoted as Point B. Turn at a 90° angle, travel 75 feet west along the cultivated field until you reach Woodsdale Road. Turn at a 90° angle and travel 150 feet north along Woodsdale Road until you reach the northwest corner of the yard, denoted as Point D. Turn at a 90° angle and travel east 75 feet along the yard line until you reach Point A.

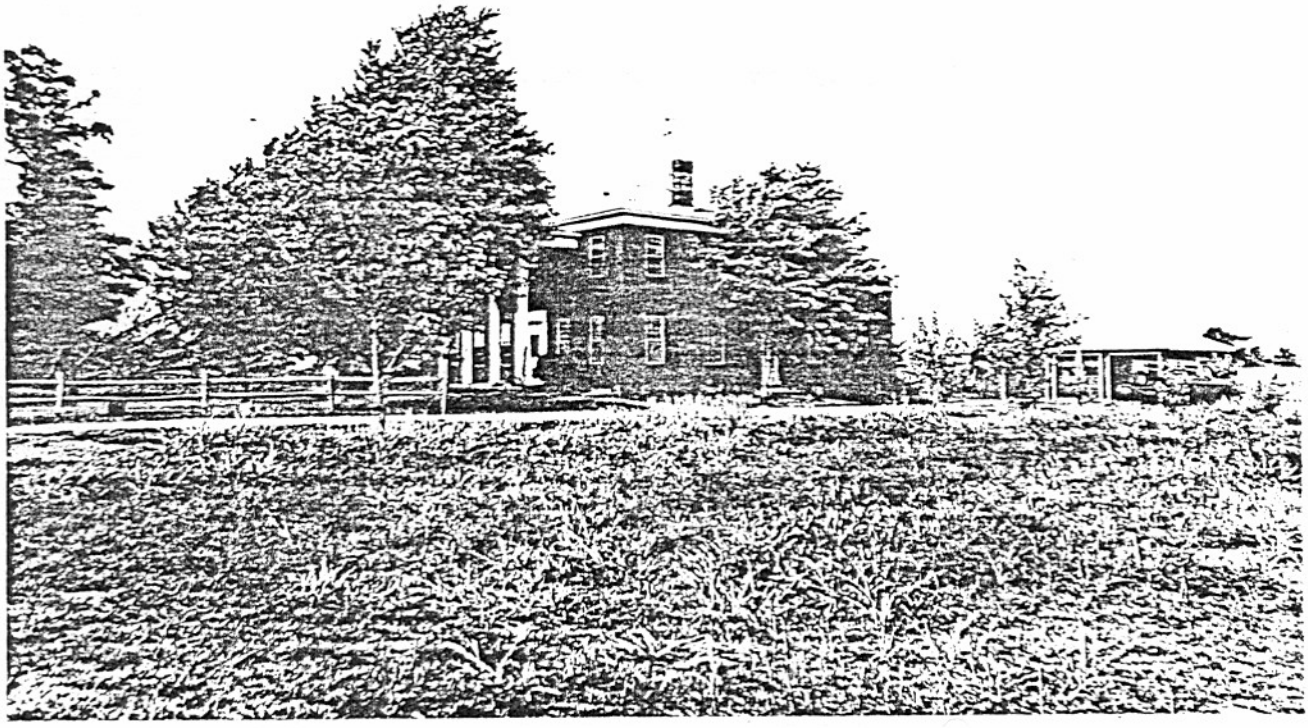
Christian Augspurger Amish Mennonite Settlement
Christian Ehresman Farm (#6) #10
Mary Ann Brown, August, 1983, WSU
South and west facades plus modern garage
in background
Photographer facing northeast

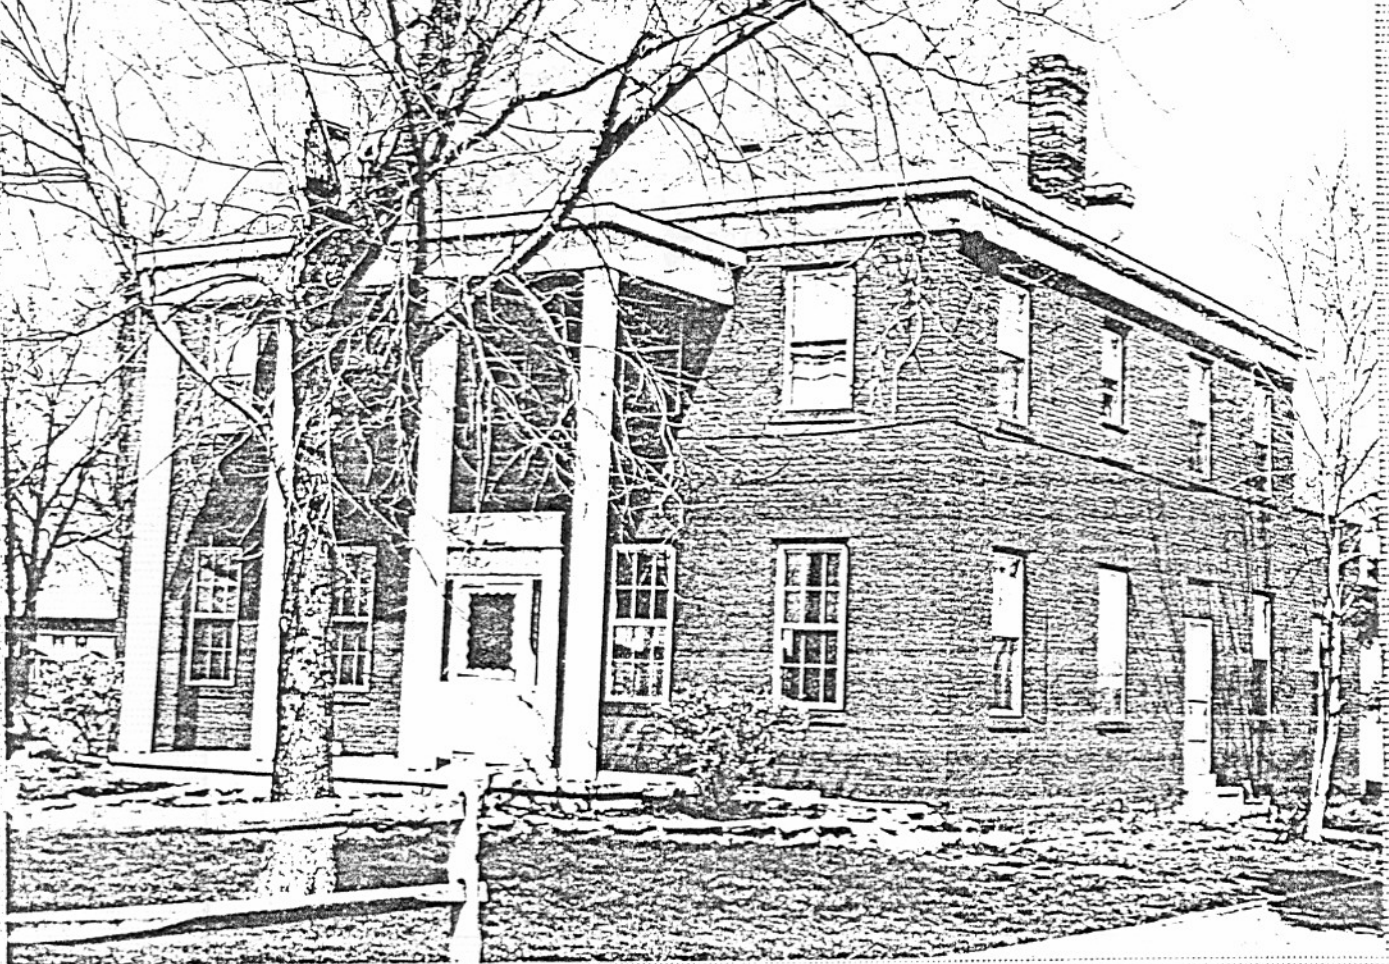
Christian Augspurger Amish Mennonite Settlement #20
Christian Ehresman Farm (#6)
Butler County, Trenton vic., Ohio
Wesley Page, 1983, Trenton Historical Society
Face and south side of house
Photographer facing northeast

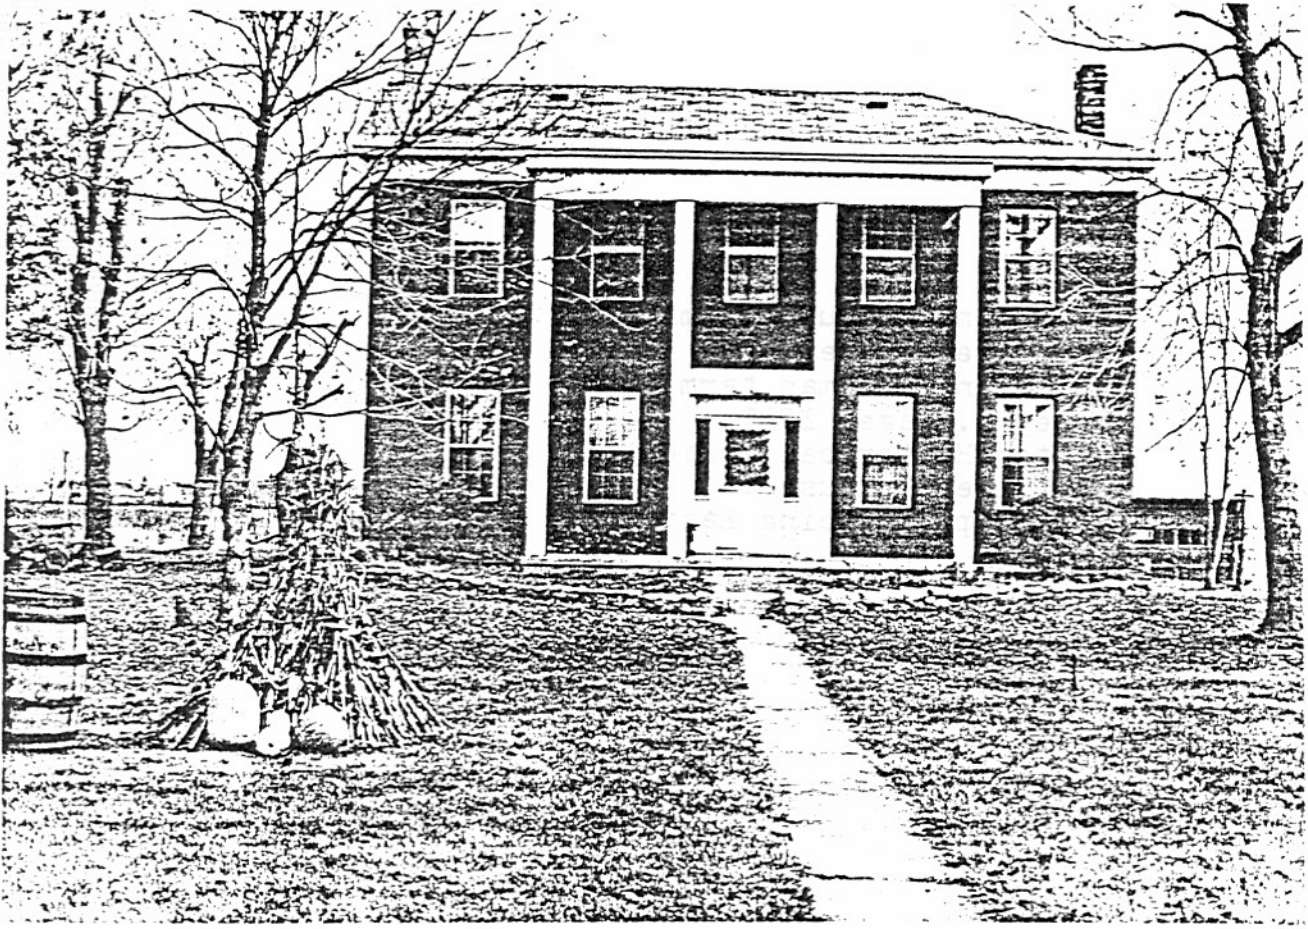
21

Christian Augspurger Amish
Mennonite Settlement
Christian Ehresman Farm (6)
Wesley L. Page, 1982
Trenton Historical Society
West Side of House
Photographer facing East

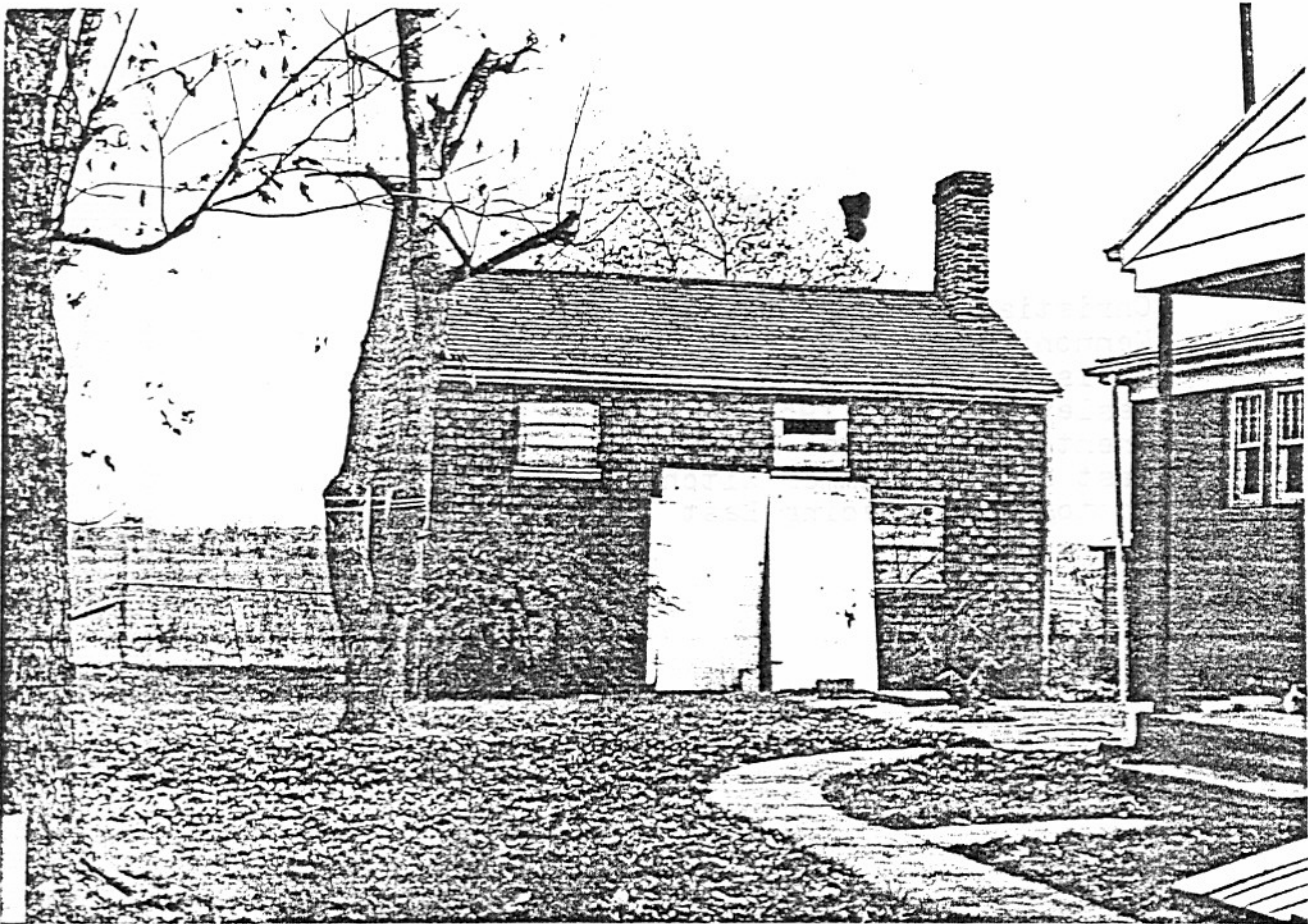
25

Christian Augspurger Amish
Mennonite Settlement
Christian Ehresman Farm (6)
Wesley L. Page, 1982
Trenton Historical Society
West Side of Summer Kitchen
Photographer facing East

44. Description of Environment and Outbuildings There is a modern garage on the farm. The farm is just south of the village of Trenton. A 1 $\frac{1}{2}$ story frame house with "lie on your stomach" windows in the half story has a large chimney to the south. This unusual building has perhaps been used as a summer kitchen, but it resembles the structure affixed to Christian Ehresman's house.
